Harry S Truman National Historic Site

Truman Home HS-01
Truman Carriage House HS-02

Historic Structures Report

Architectural Data Section
Existing Condition Drawings

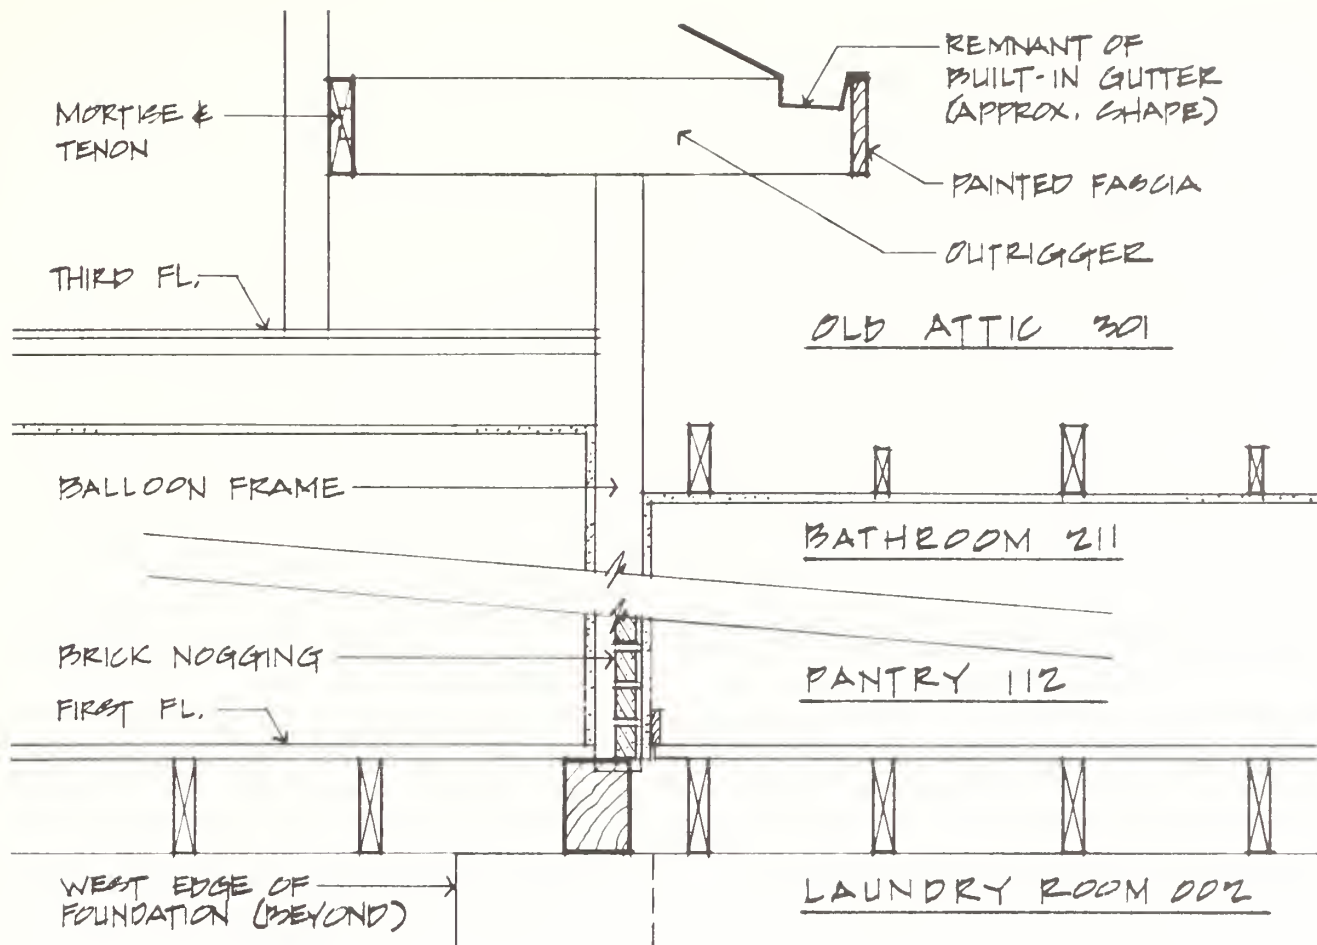
Fig. 1.2 Truman Home. Construction detail of connection between main house and kitchen wing. Credit: Doug Wasama

Resembling the massing of a two-story American I-House, the 1867 structure is shown with a medium-hip roof. Recent investigation at the west end of the old attic (301) revealed extant framing of a hip roof with painted fascia board and remnants of a built-in sheet metal gutter. Thus, the east wall of Truman dressing room (209) and hall (208) was originally an exterior wall. The smaller kitchen wing (kitchen 113, pantry 112, butler's pantry 111) is shown with a shallow-pitched, gable roof. A September, 1986 physical investigation revealed that the kitchen wing (113) was balloon framed at the floor joists, north wall. In addition, there is evidence of an intermediate kitchen partition. Presumably, the kitchen wing was constructed as a one-story or one-and-one-half story addition with the roof altered to its existing height and configuration in the remodeling of 1885. (See Fig. 1.2.)

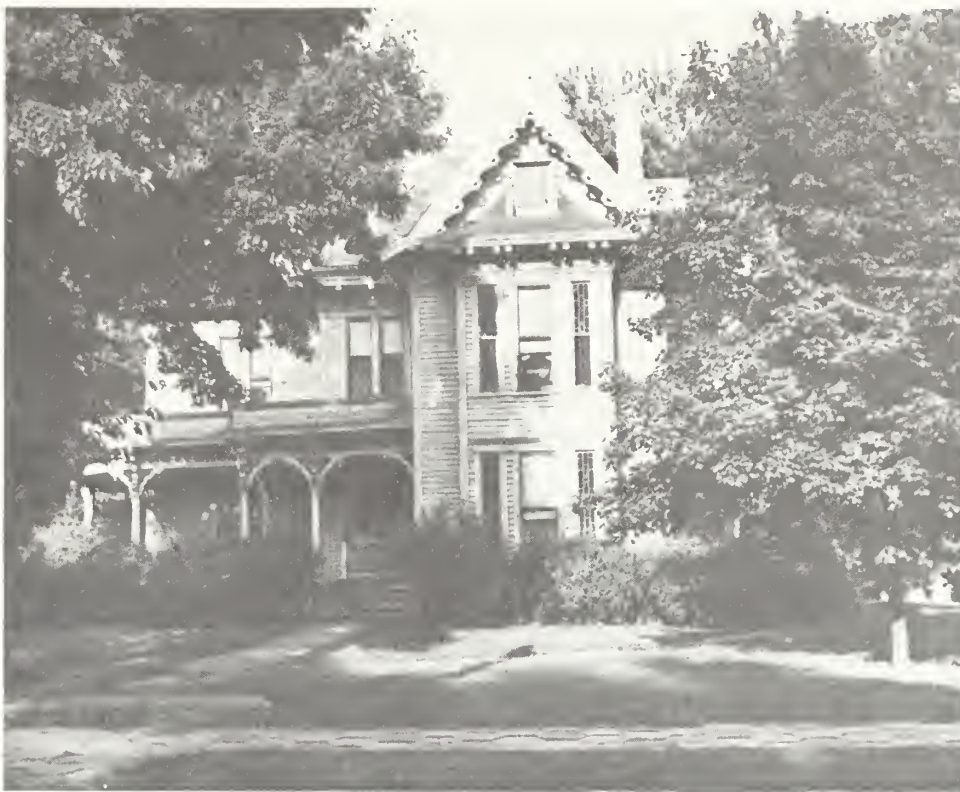
Fig. 1.8 Truman Home, July 11, 1944. West elevation (looking east). Before 1945 renovation. Credit: HSTL

For more than a decade---from the time that Harry Truman won the 1934 Democratic nomination for the United States Senate until 1945 when he became the thirty-third President of the United States---the house at 219 North Delaware was neglected. Although minor in nature, there were several household repairs accomplished, yet by the spring of 1945, the property was in need of major renovation.²⁰ (See Figs. 1.8 and 1.9.)

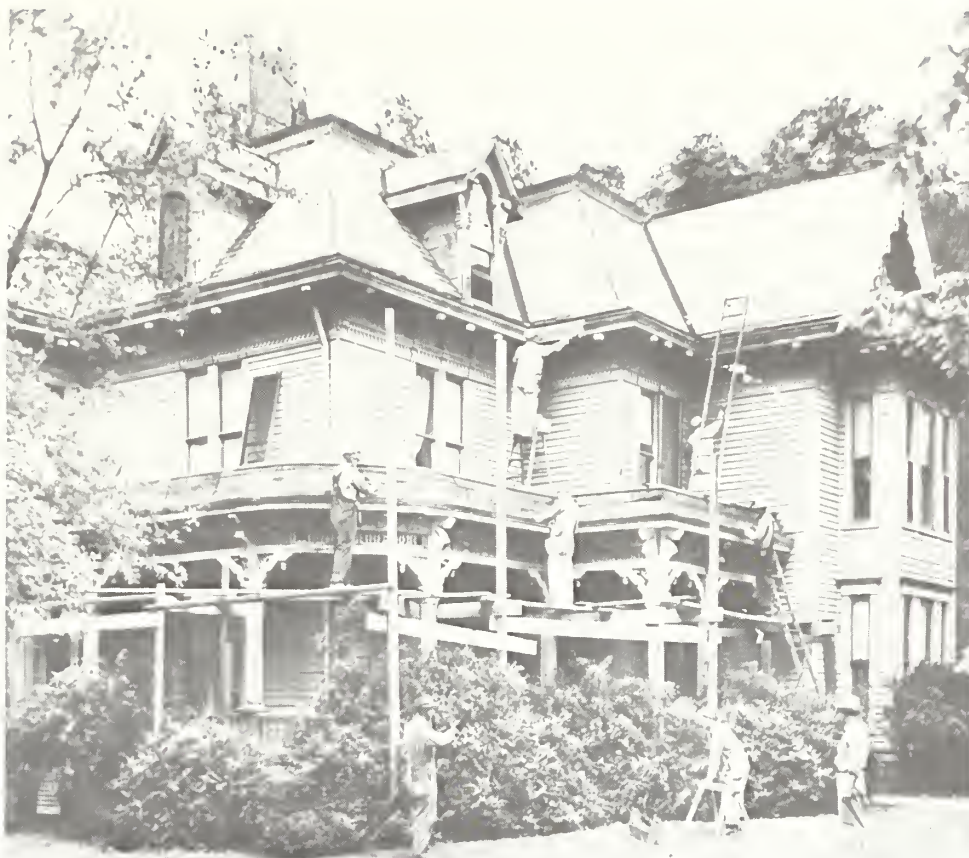
Fig. 1.10 Truman Home, May 21, 1945. West elevation (looking southeast). Workers begin renovation. Credit: HSTL

Concerned about the appearance of her family home, Bess Truman made arrangements to begin exterior renovation of "The Summer White House" as it was then called. (See Figs. 1.10 and 1.11.) Work at 219 North Delaware included replacing rotted millwork and slate shingles, covering the worn, grey exterior with white paint, and trim areas with Kentucky green.²¹ The second floor bath (211) was also remodeled with a new blue porcelain tub, stool, and sink.

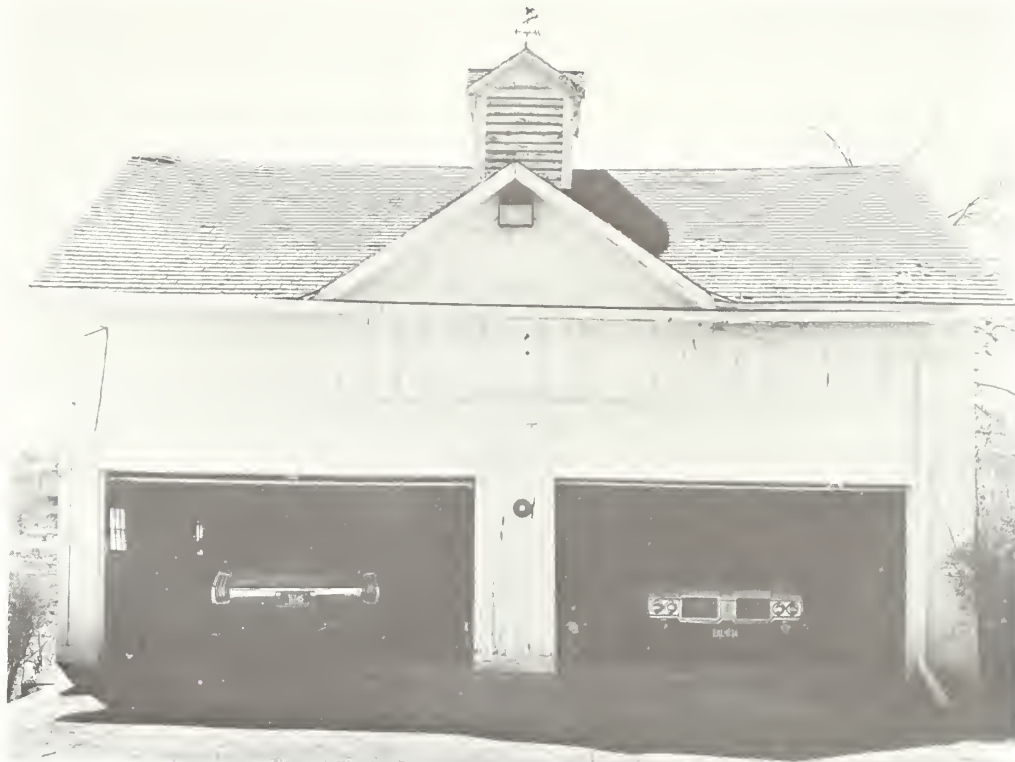
Fig. 3.1 Truman Carriage House, Fall 1985. North elevation (looking south). Credit: Zoom Studios

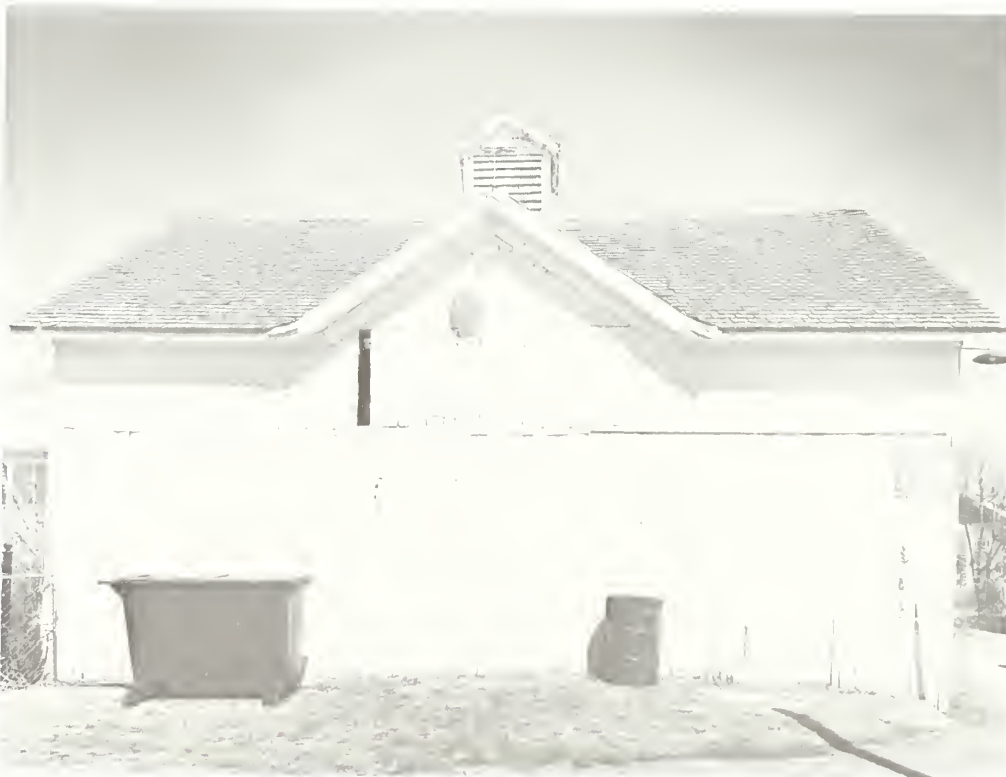
Drainage around the structure is generally very poor. At the south elevation adjacent to the alley, soil and gravel has been built up to obtain positive drainage away from the Carriage house. Unfortunately, the exterior grade now rises above the interior grade of the concrete floor slab. This has led to severe deterioration of the siding, foundation sill and structural post bases. It appears that the exterior grade has been raised at least 20 inches along the south elevation with

No gutter exists on the south elevation. Lack of proper roof drainage and site grading which is sloped towards the south wall instead of away from it has caused the lower ends of the siding to decay. A gutter and downspout should be installed on this elevation and the site regraded to facilitate drainage away from the building.

Fig. 3.2 Truman Carriage House, Fall 1985. South elevation (looking north). Credit: Zoom Studios

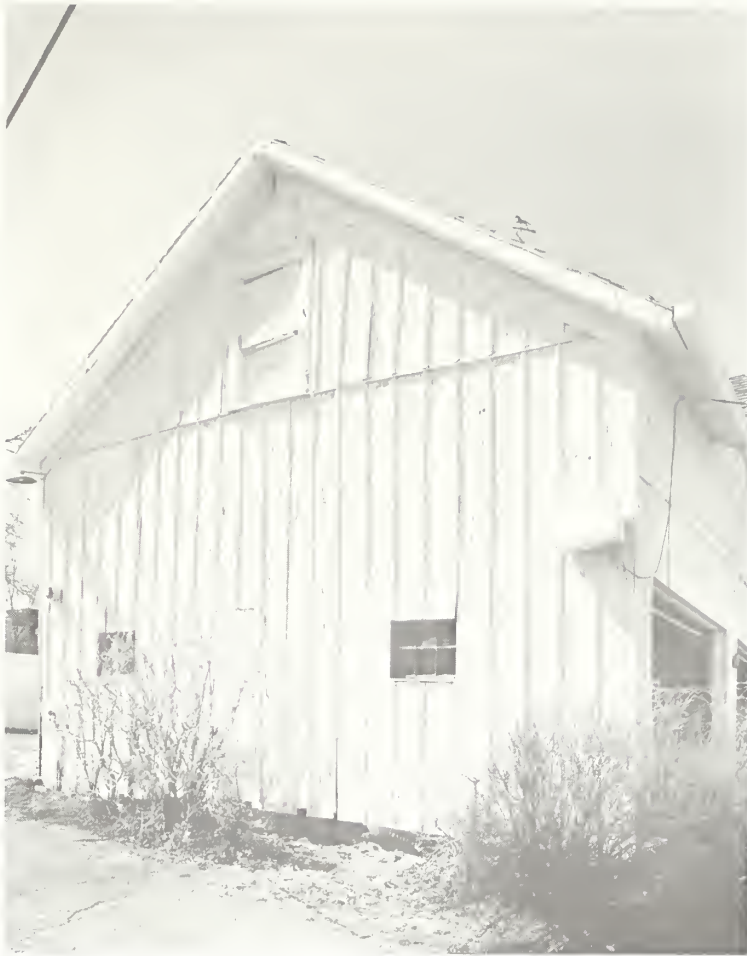
The grade along the east elevation is approximately 1 foot below the top of the foundation wall. Moisture problems are not apparent; there is a slight slope away from the building towards the driveway.²

The siding on the east elevation exhibits numerous open joints and missing or non-original battens. Relative to the west elevation, it is in poor condition. The edge is not in direct contact with the soil and is in sound condition.

Fig. 3.3 Truman Carriage House, Fall 1985. East elevation (looking west).
Credit: Zoom Studios

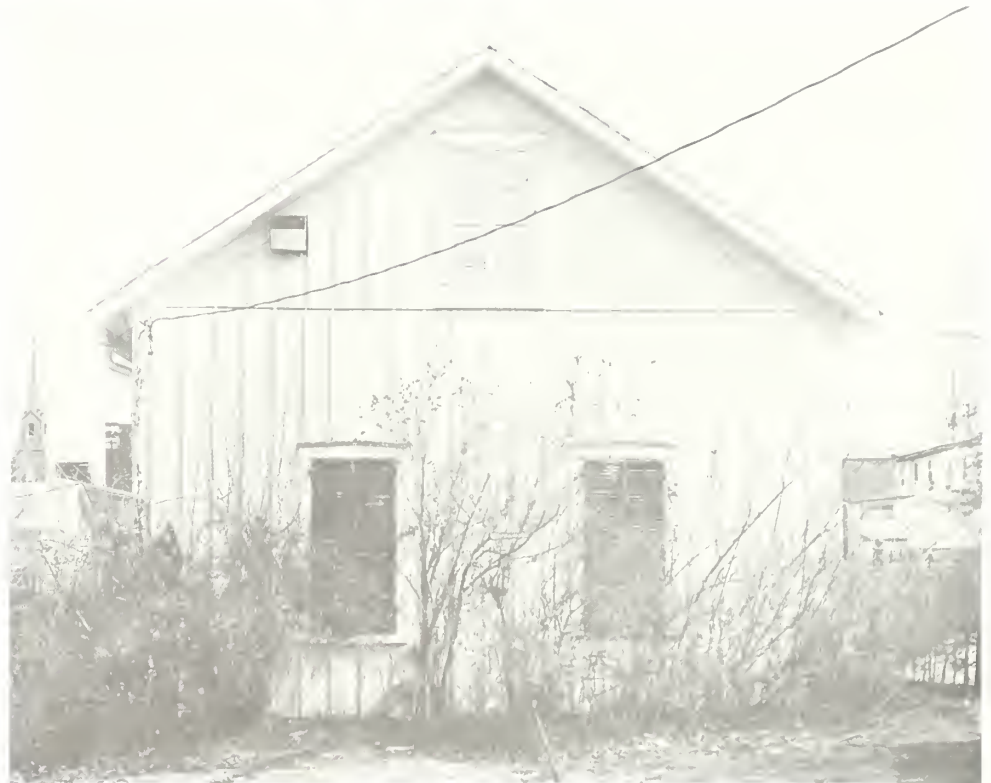
The west elevation shares some of the same problems as the south elevation. The soil has been built-up 2 inches above the top of the foundation wall. Tall, thick bushes along the west elevation have compounded moisture problems by reducing ventilation and sun exposure. The only downspout on the building drains rain water at the northwest corner. Negative slope causes water to pond in this area.

Fig. 3.4 Truman Carriage House, Fall 1985. West elevation (looking east).
Credit: Zoom Studios
